# Case Study Breaking Down Barriers

Replacing an Aging GE System with a DECS-2100 Excitation System

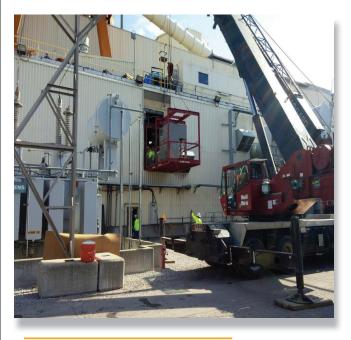
Figure 2 - Loading the new DECS-2100 into the facility

Upon arrival, the pieces were numbered and moved into the powerhouse using the same hole created for equipment extraction. E<sup>2</sup>PS also specified an airconditioned control house to protect the DECS-2100 system from the harsh powerhouse environment.
